**PRELIMINARY ASSESSMENT/
VISUAL SITE INSPECTION**

**1330 SOUTH KILBOURN AVENUE FACILITY
FORMERLY THE VALSPAR CORPORATION - PAINT
CHICAGO, ILLINOIS**

FINAL REPORT

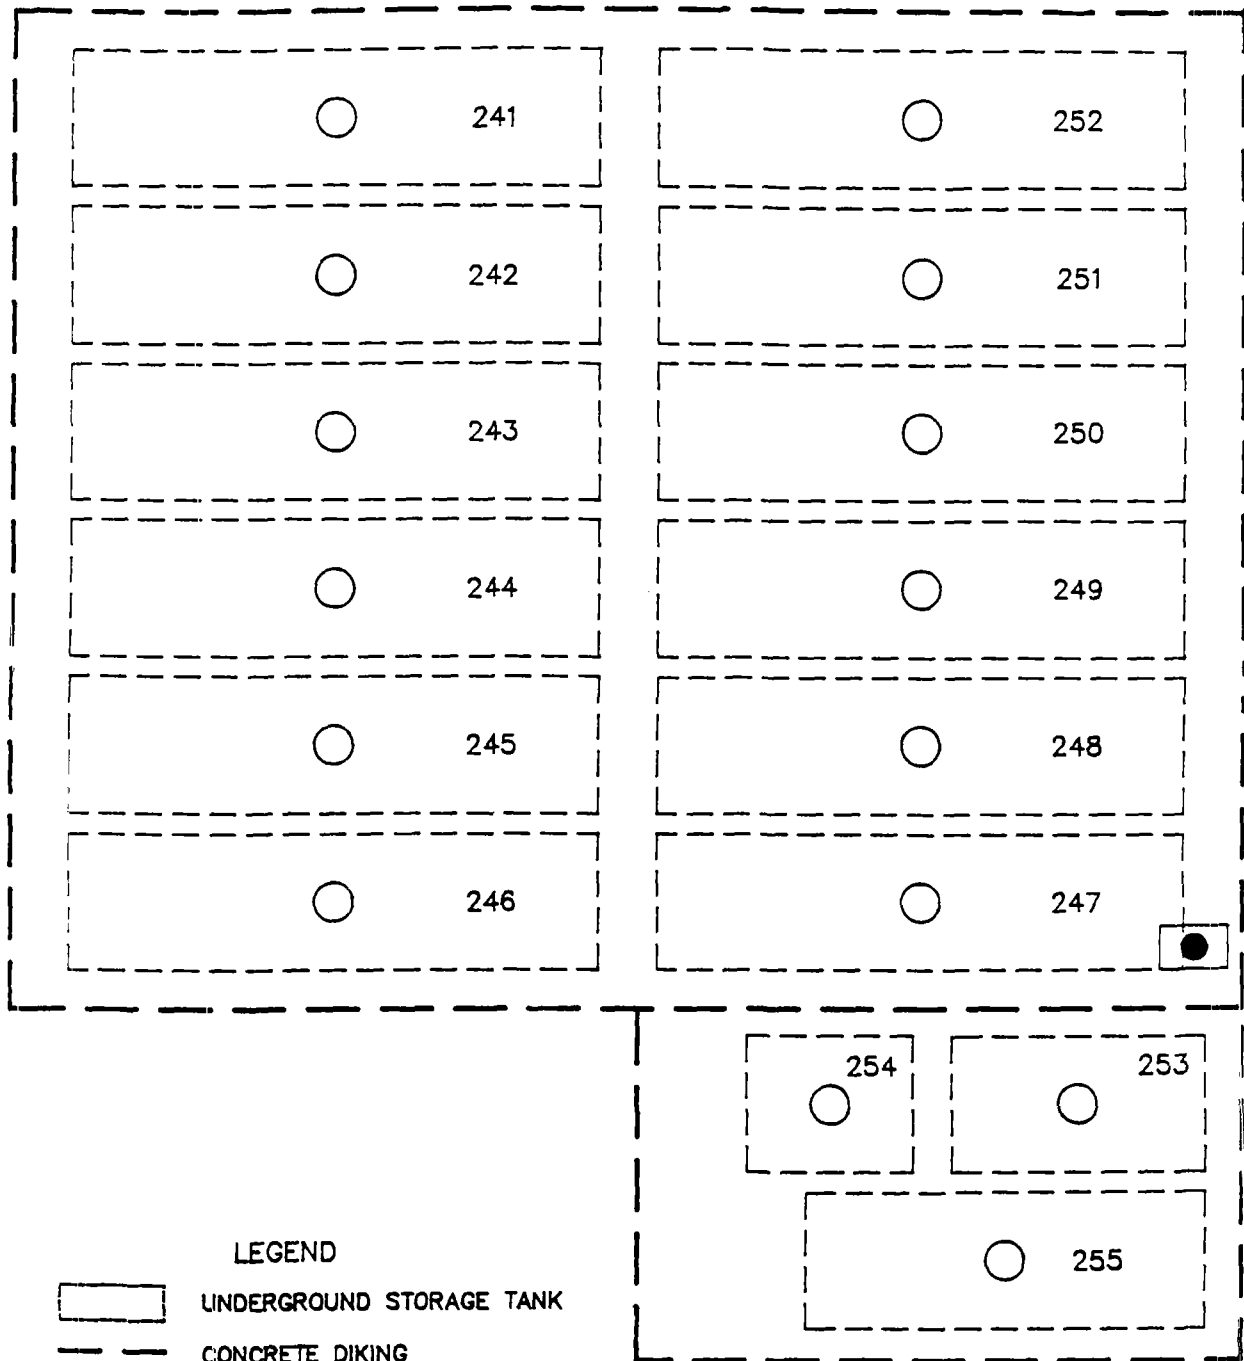
FIGURE 3
NORTH TANK FARM

The North Tank Farm contains 15 underground storage tanks. The locations of the tanks in the North Tank Farm are shown in Figure 3. A summary of the tanks in the North Tank Farm is presented in Table G-1 of Attachment G. Twelve of the tanks have volumes of 8,000 gallons; the other three tanks have volumes less than or equal to 6,000 gallons. Because the North Tank Farm is surrounded by concrete walls about 5 feet high and contains a sump to drain the soils around the tanks, Valspar believes the tanks are enclosed within a concrete vault (IT, 1990b). The integrity of any concrete beneath the tanks, if it exists, is unknown. PRC did not locate any record of borings into the North Tank Farm during the PA and thus could not confirm that concrete underlies the tanks.

Based on information gathered during the PA, PRC attempted to identify the past contents of the tanks in the North Tank Farm. According to the Valspar's May 1990 Closure Plan, three of the 15 tanks in the North Tank Farm require closure, because they were found to contain hazardous waste material in 1985 during response actions initiated by the 4(q) Notice. Tanks containing butyl acetate (D001), butanol (U031), and mineral spirits (D001) were emptied and cleaned. The other 12 tanks were found to be empty (Waste Reduction, 1985). According to the Settlement Proposal, all 15 tanks are currently empty (IT, 1990b).

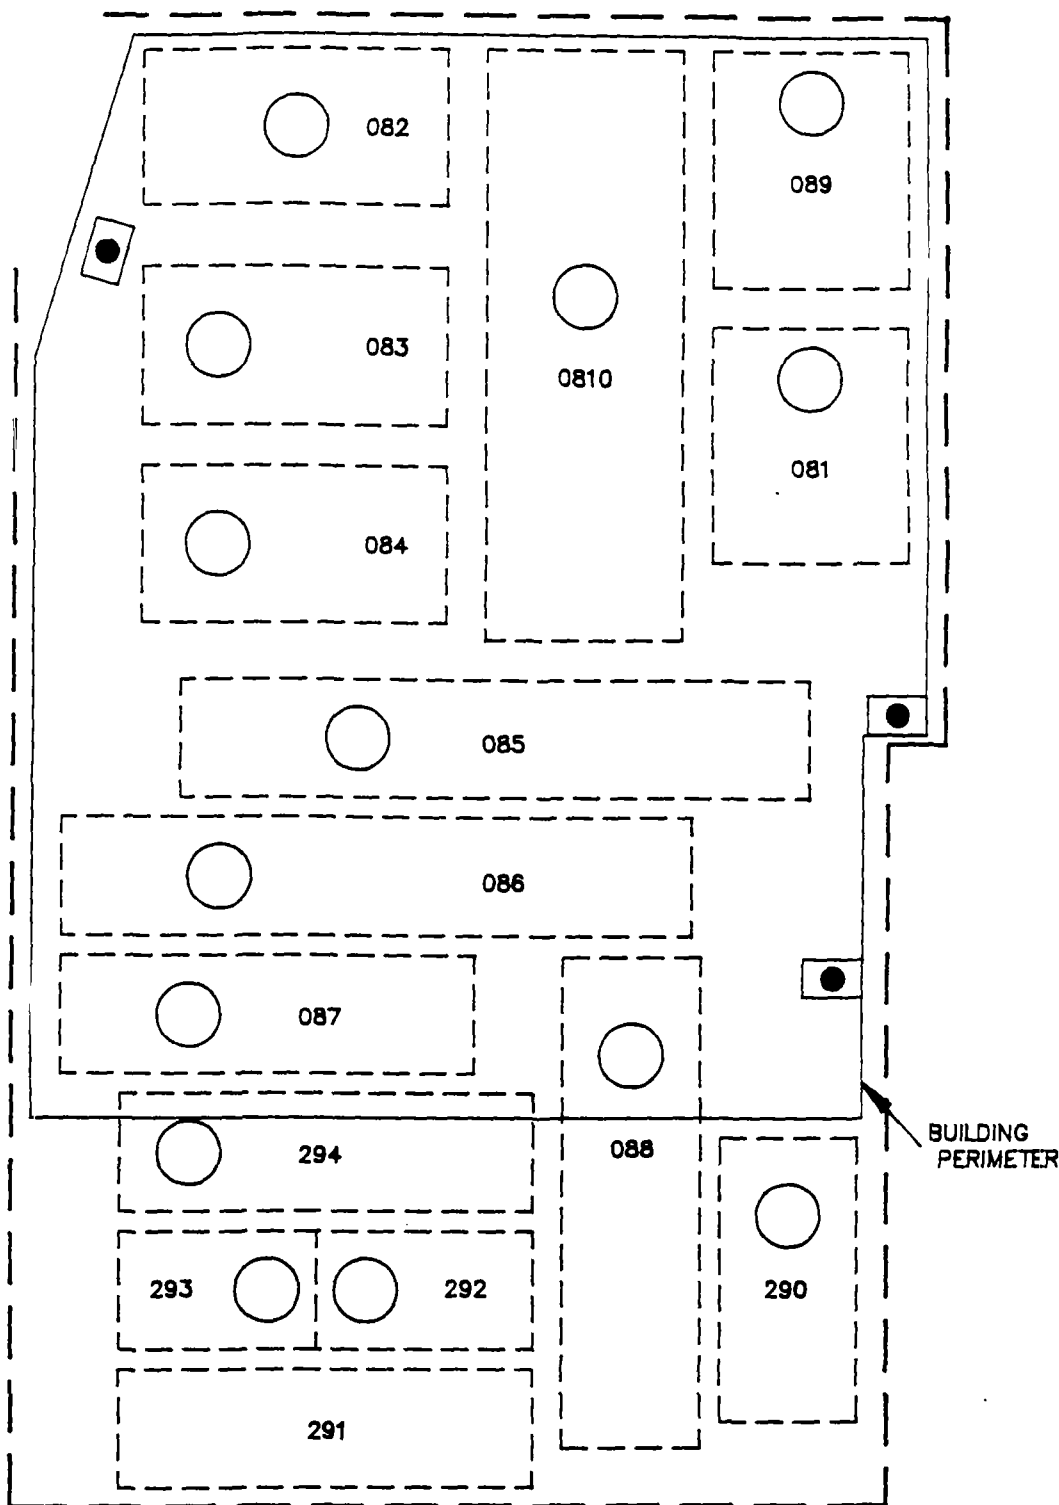
FIGURE 5

The Cooper's Pit contains 15 underground storage tanks, 10 of which are actually located within the walls of Building 7-C (Waste Reduction, 1985). The locations of the tanks in the Cooper's Pit are shown in Figure 5. A summary of the tanks in the Cooper's Pit is presented in Table G-3 of Attachment G. The tanks range in volume between 4,050 and 25,000 gallons. Two of the tanks have volumes less than 5,000 gallons; seven have volumes between 5,000 and 10,000 gallons; and six have volumes greater than 10,000 gallons. The Cooper's Pit is surrounded by concrete walls on all sides, and borings into the soils in this area below the depths of the tanks have hit concrete (IT, 1990b). The integrity of the concrete beneath the tanks is unknown. PRC could not confirm that the concrete beneath the tanks is connected to the walls surrounding the Cooper's Pit.

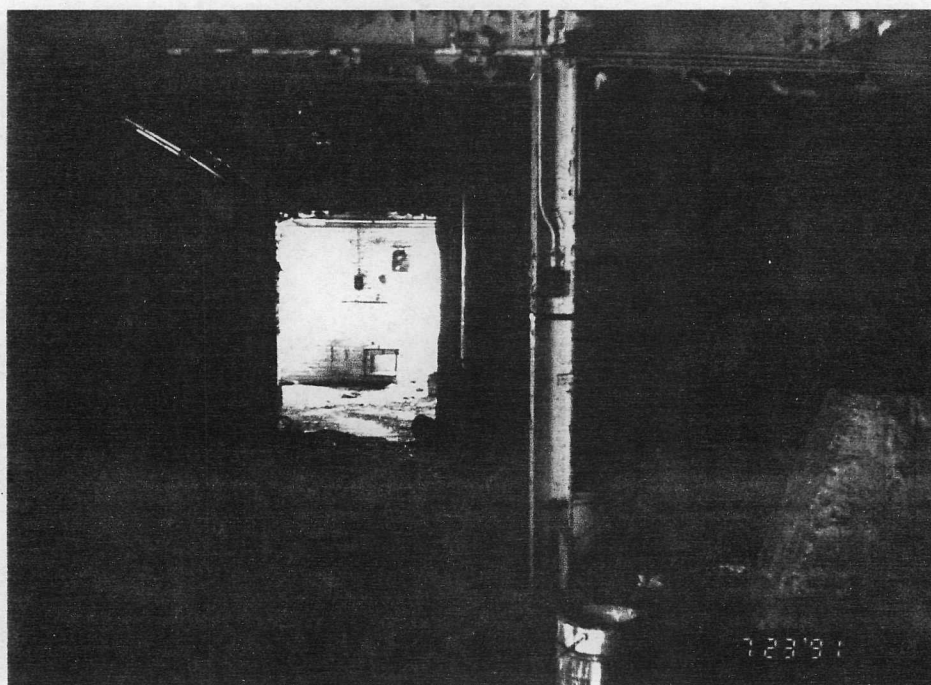
Photograph No. 2

Description: This picture shows the middle room of the complex consisting of Buildings 1 and 2. Two empty tanks are visible in the right background and behind the column in the center of the picture.

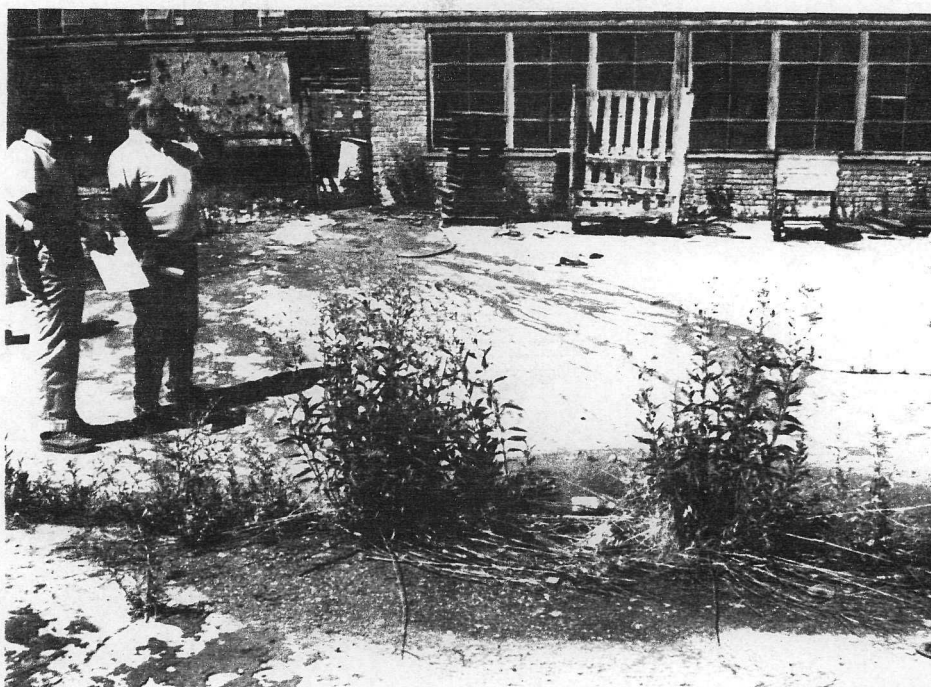
Photograph No. 5

Description: This picture shows the paved area located east of Building 25 and south of Buildings 1 and 2. Several past paint spills can be seen in the picture, and the spill path leads to a drain located in the bushes in the foreground. Neither Goodwill nor Valspar representatives knew where the drain's outfall is located.

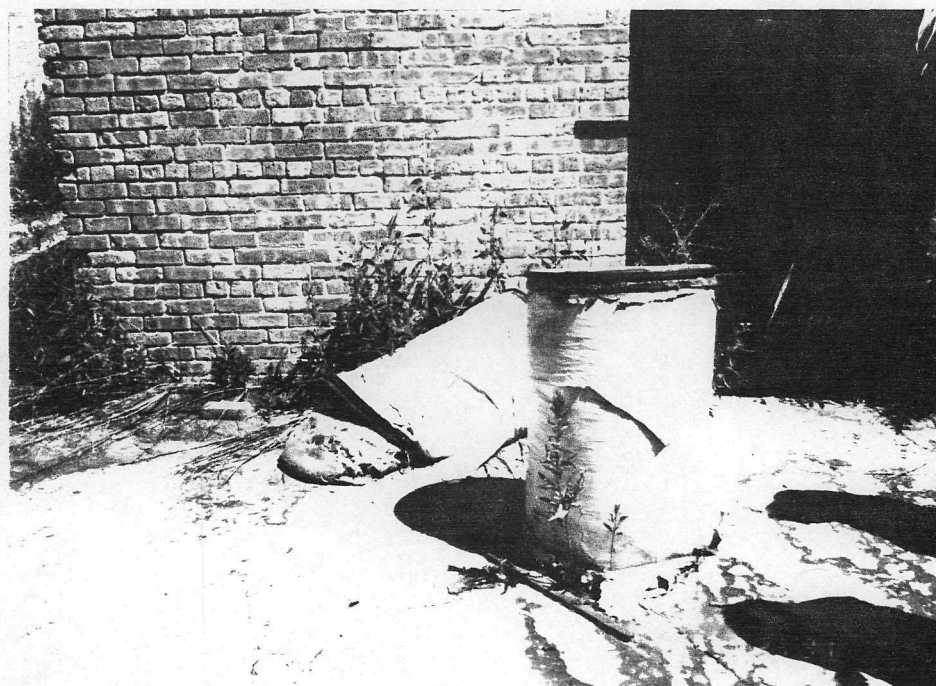
Photograph No. 6

Description: This picture shows two badly deteriorated cardboard drums oozing a thick, milky substance onto the asphalt lot south of Building 25. The substance was identified as latex by Valspar representatives.

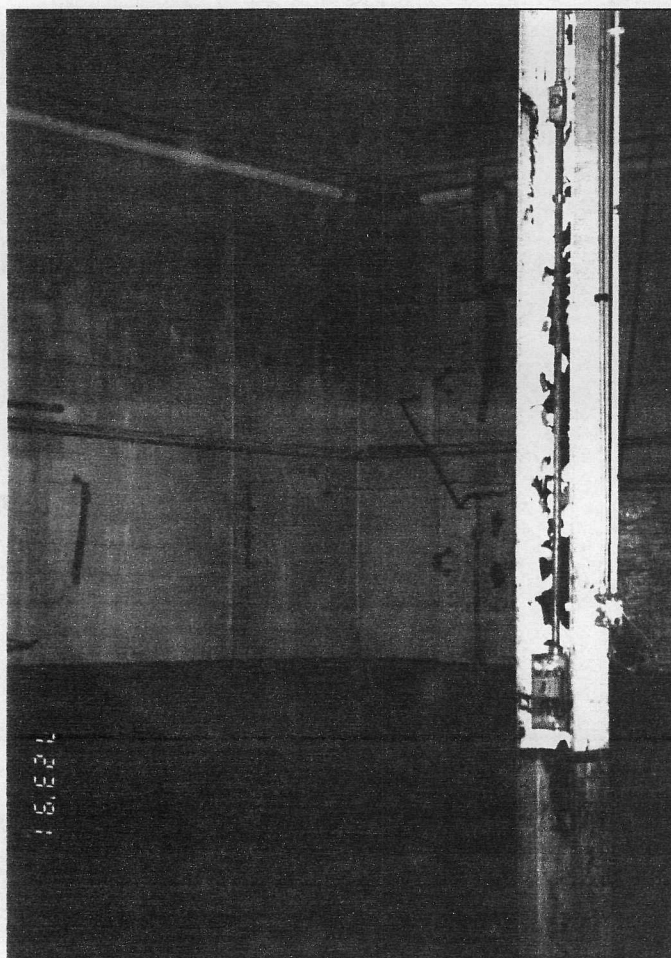
Photograph No. 14
Location: Building 15-A
Orientation: Southeast
Date: 07/23/91
Description:

Building 15-A is a one-story building located in the south-central portion of the facility (see photograph 14). The building's floor was littered with debris and dust, but the building appeared empty. Paint was peeling off the walls and columns in this building, and piping insulation was observed on the floor and wrapped around pipes running along the building's walls. PRC did not observe any tanks in this building, but information provided to PRC after the VSI indicates that Valspar used three tanks in Building 15-A. However, these tanks were removed prior to 1985 (IT, 1990b). The ceiling of this building appeared to be about 30 to 40 feet above the floor. PRC determined that this building has an estimated floor space of about 2,100 square feet (see Table 1).

This picture shows an overall view of Building 15-A. The room is currently empty except for miscellaneous trash on the floor.

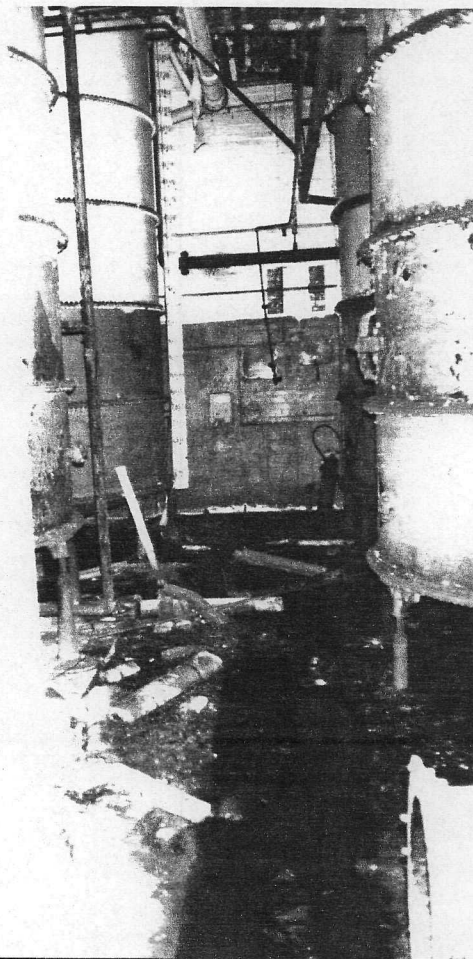
Photograph No. 23
Location: Building 3-B
Orientation: North
Date: 07/23/91
Description:

This picture shows the piping running between the tanks in Building 3-B. It is between 10 and 15 feet above the building floor. Note the piping insulation on two of the pipes. It may contain asbestos.

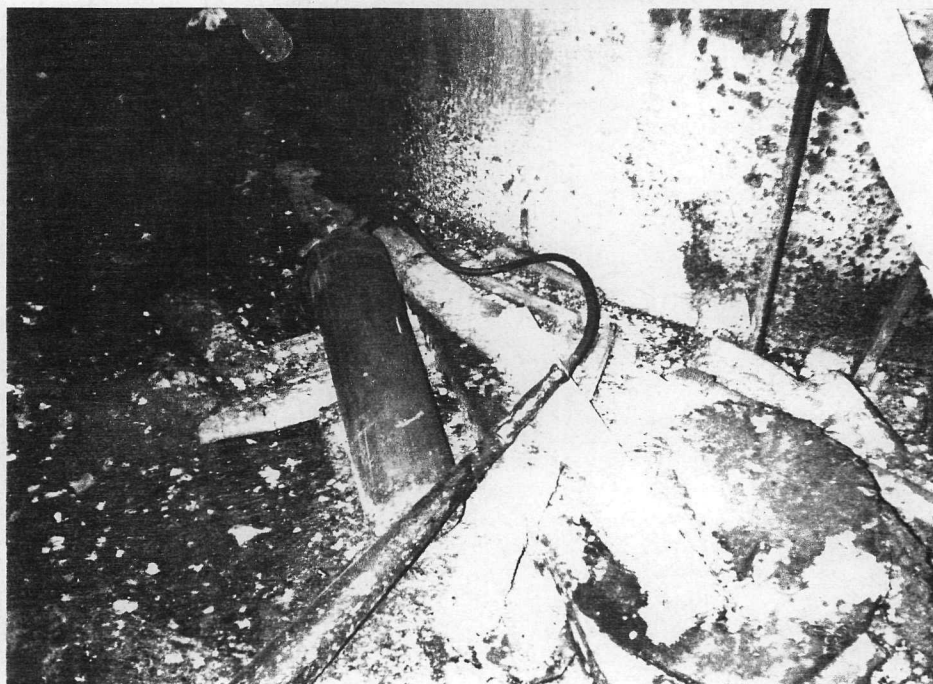
Photograph No. 24
Orientation: North

Description: This picture shows the floor in Building 3-B. The picture was taken from the same location as Photograph No. 23. Note the standing liquid on the floor, the deteriorated condition of the grates, the trench, and the piping insulation, which may contain asbestos.

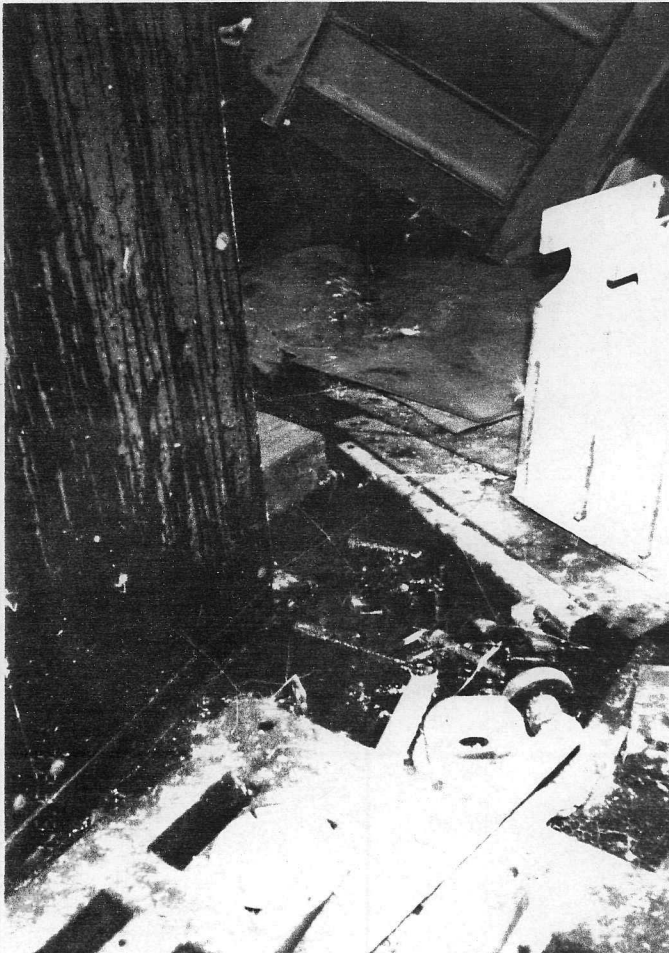
Photograph No. 26
Location: Building 3-F
Orientation: Northeast
Date: 07/23/91
Description:

This picture shows a portion of Building 3-F. The inspection team noted oil stains on the floor near an old transformer. The oil may contain PCBs. The inspection team also noted piping insulation in this building. The insulation may contain asbestos.

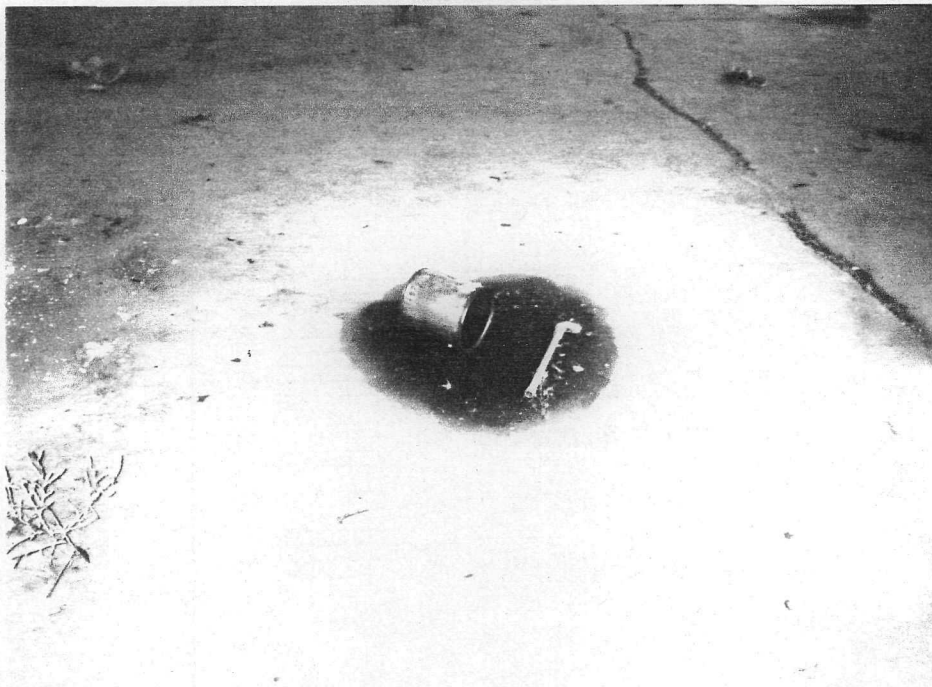
Photograph No. 27

Description: This picture shows an overturned bucket of what appeared to be oil in Building 3-F.

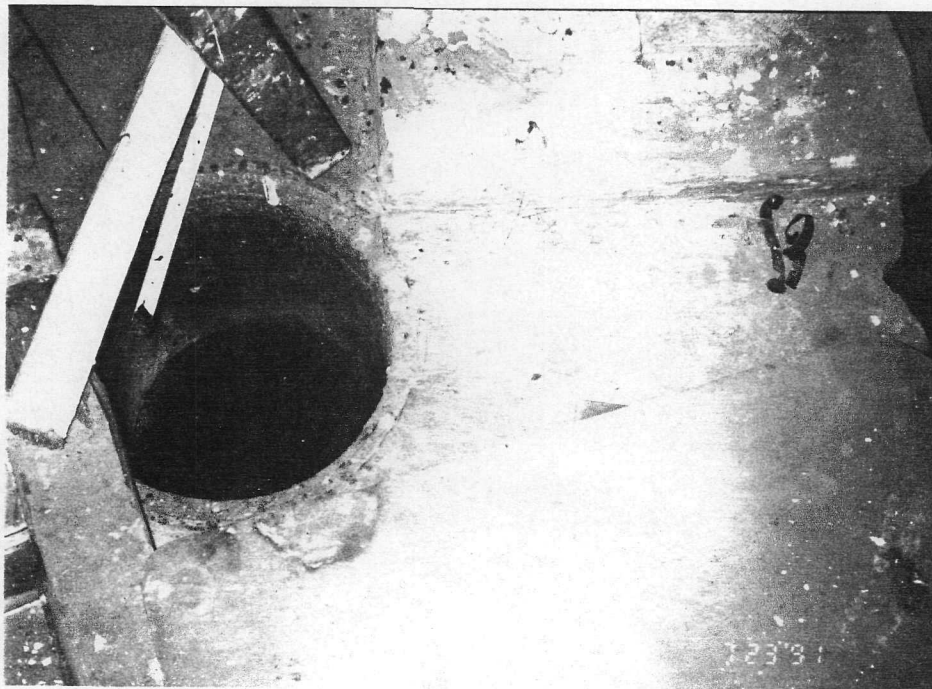
Photograph No. 28

Description: This picture shows a sump in Building 3-F. The entire room was surrounded by trenches, and it appeared that the trenches drained into this sump through the channel running from right to left in the picture. Note the piping insulation. It may contain asbestos.

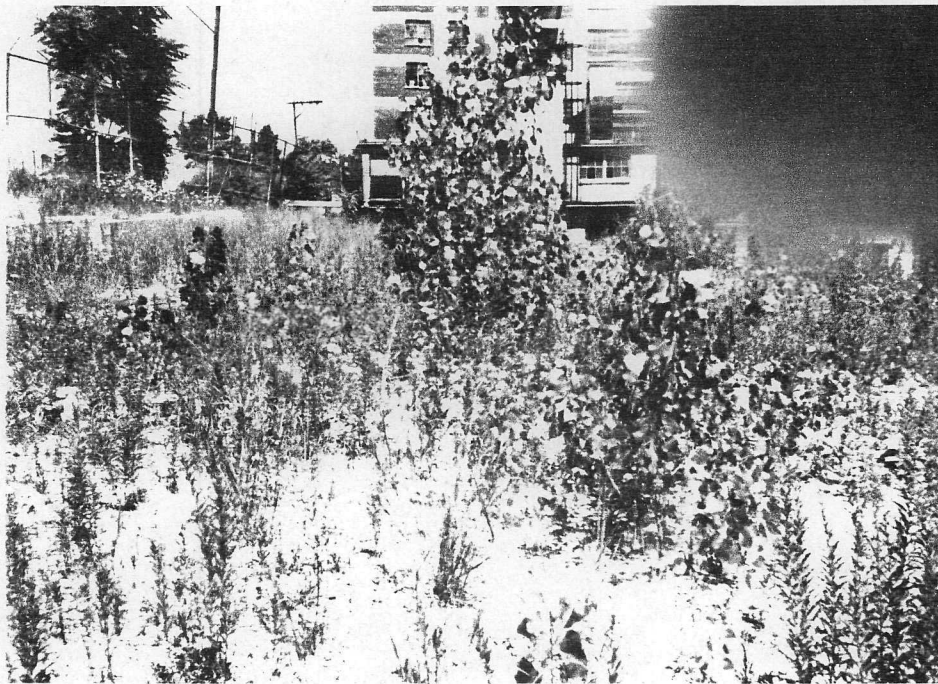
Photograph No. 32
Orientation: North

Description: This picture shows the western portion of the facility. At one time, this area contained the superstructures of Buildings 4, 4-A, 4-B, 4-C, 17, 17-A, 21, and 22. These buildings have been demolished, and the lot has been graded with fill over the foundations, which remain.

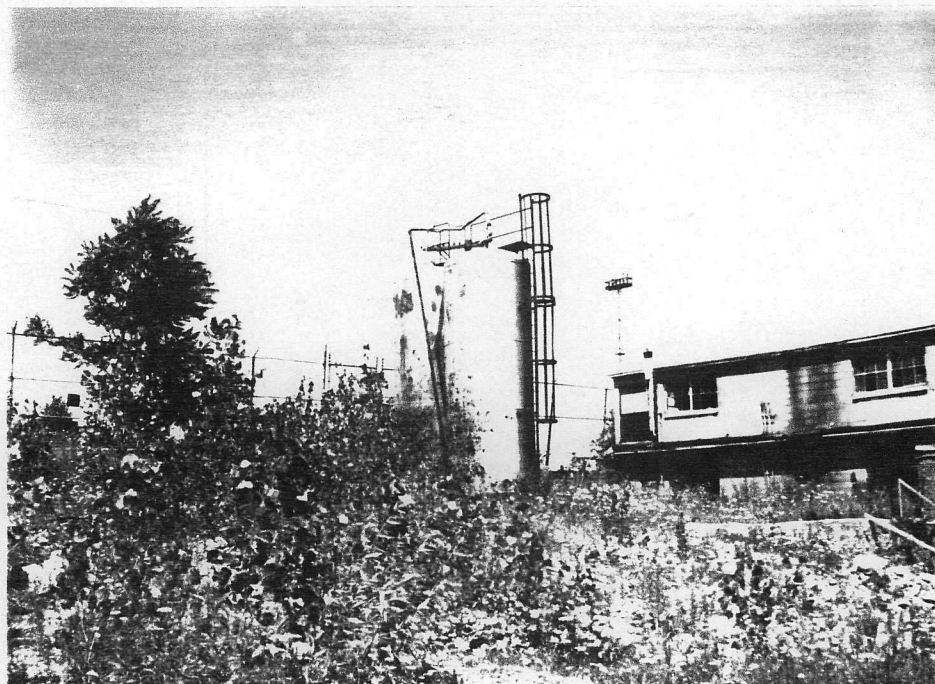
Photograph No. 34

The only remaining, standing structures near the former resin production buildings are two, vertical, steel tanks (see photograph 34). These tanks each have a capacity of 20,000 gallons (IT, 1990b). PRC could not determine what these tanks stored.

Description: This picture shows Tanks 295 and 296. According to Valspar representatives, these tanks were probably solvent storage tanks when Valspar used the facility.

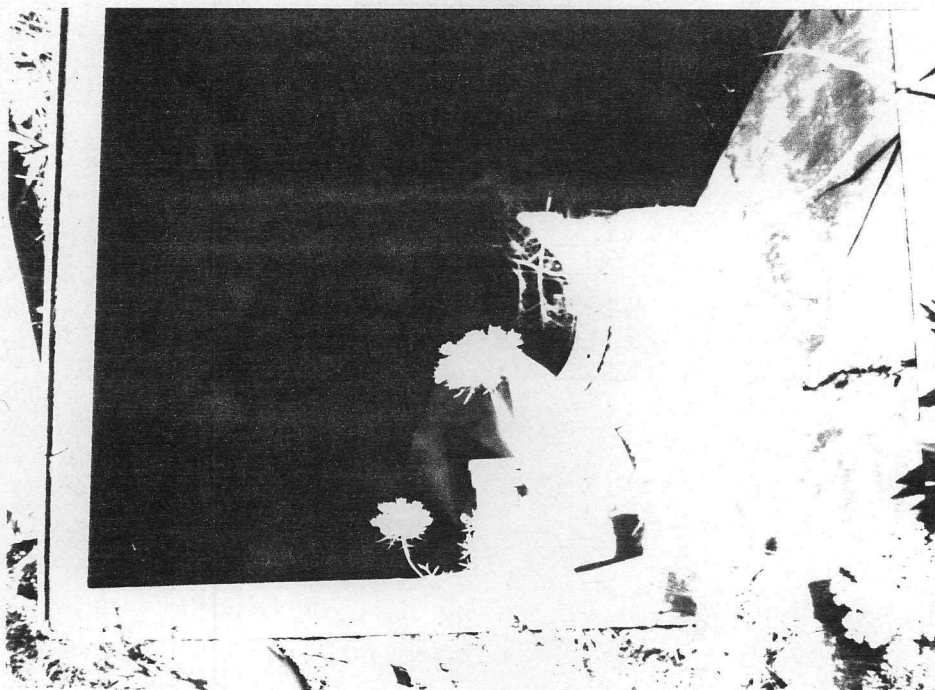
Photograph No. 35

Description: This picture shows an accessway into an underground storage tank south of the Cooper's Pit (Building 7-C). Two of these accessways were located during the VSI; more may be present.

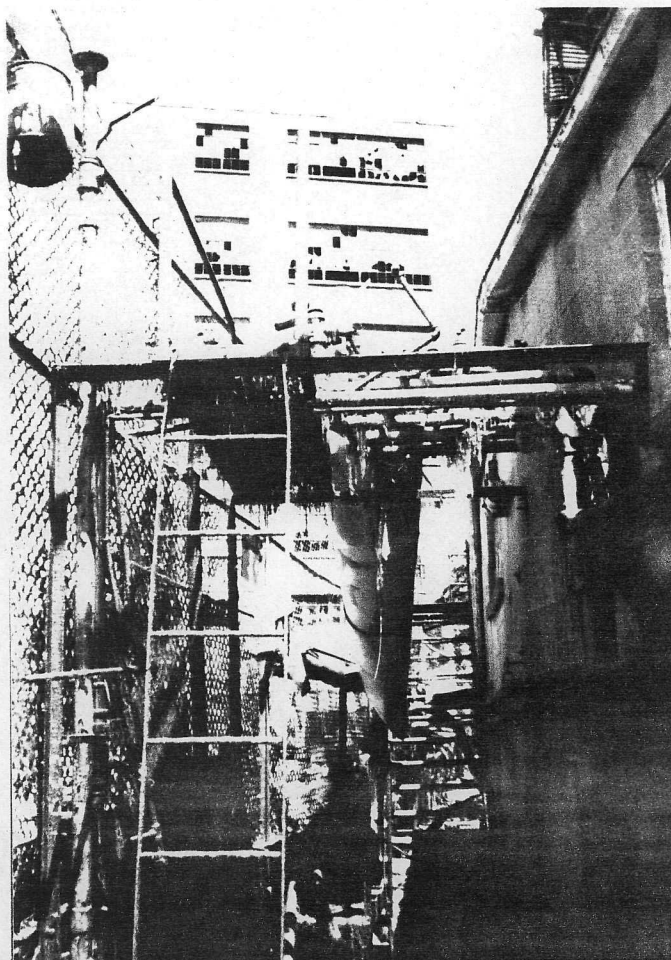
Photograph No. 37
Location: West of Cooper's Pit
Orientation: North
Date: 07/23/91
Description:

This picture shows the leaking pipes on the west side of the Cooper's Pit. The leaking material is forming columns that resemble stalactites. Building 7 is visible in the background.

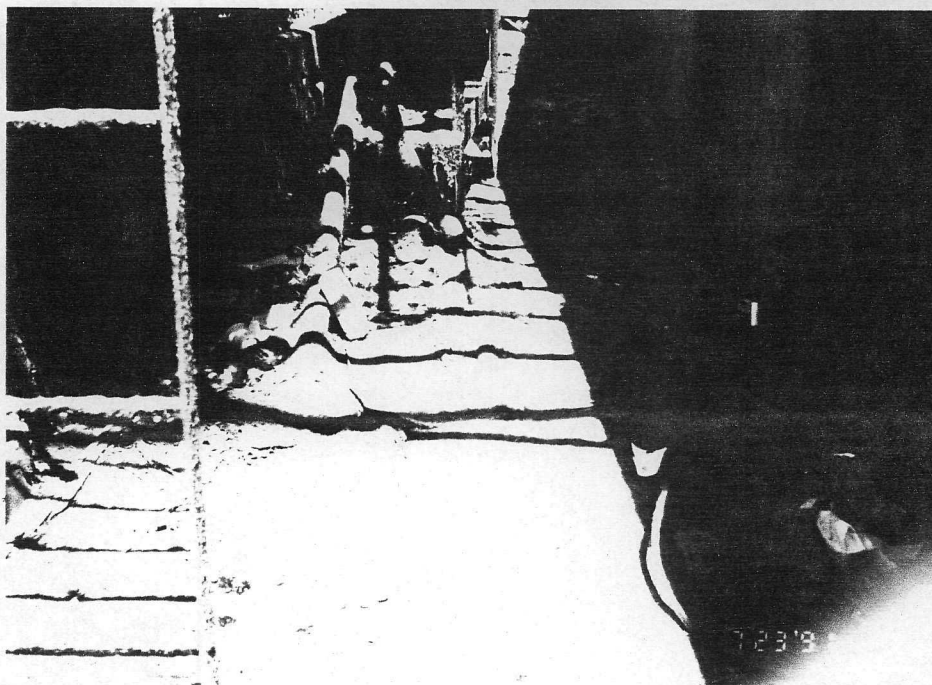
Photograph No. 38
Orientation: North

Description: This picture shows the ground underneath the leaking pipes on the west side of the Cooper's Pit. The ground in this area is spongy, and it gave way when PRC stepped on it. When the inspection team retreated from this area, it noticed that the yellowish pools of liquid visible in the picture had seeped from the solidified pools on the ground.

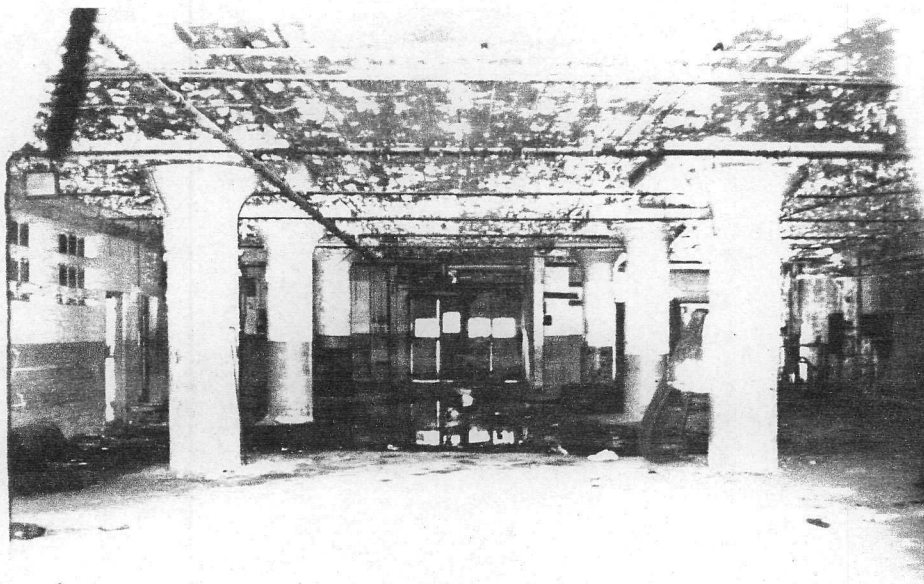
Photograph No. 41

The first floor of Building 7 is an empty room (see photographs 41 and 42). PRC observed standing liquid near the middle of the room covering about half of the floor. The west wall of the room contained graffiti. The paint on the columns, walls, and ceiling of this room was peeling and had chipped and fallen to the floor in many places. PRC observed a drum containing a light-colored, semisolid substance lying on its side during the VSI. The drum was resting in an area containing standing liquid and heavy discoloration of the walls and floor. PRC determined that this building has an estimated floor space of about 8,000 square feet (see Table 1).

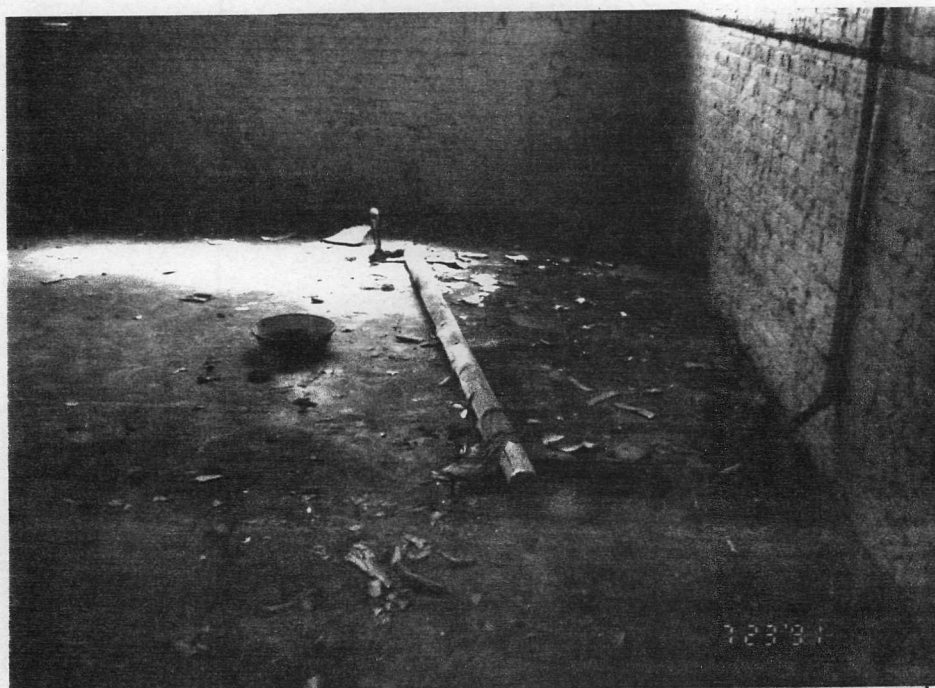
Photograph No. 44

Description: This picture shows a room in the middle of the complex consisting of Buildings 1 and 2. The floor in this room was stained with a dark, wet substance. The walls of the room were hidden by storage racks of some sort.

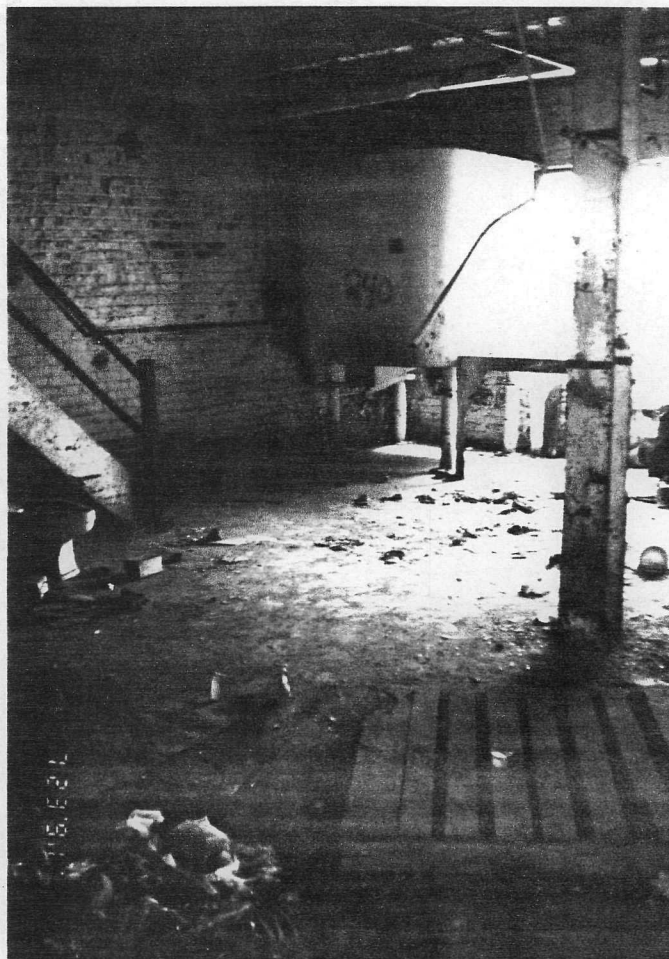
Photograph No. 45
Location: Buildings 1 and 2
Orientation: Southeast
Date: 07/23/91
Description:

This picture shows the first floor of the west room of the complex consisting of Buildings 1 and 2. This room contains Tank 240. Several bags of used PPE were seen during the VSI. These bags had been ripped open and strewn about, possibly indicating that an unauthorized person had gained access to the site.

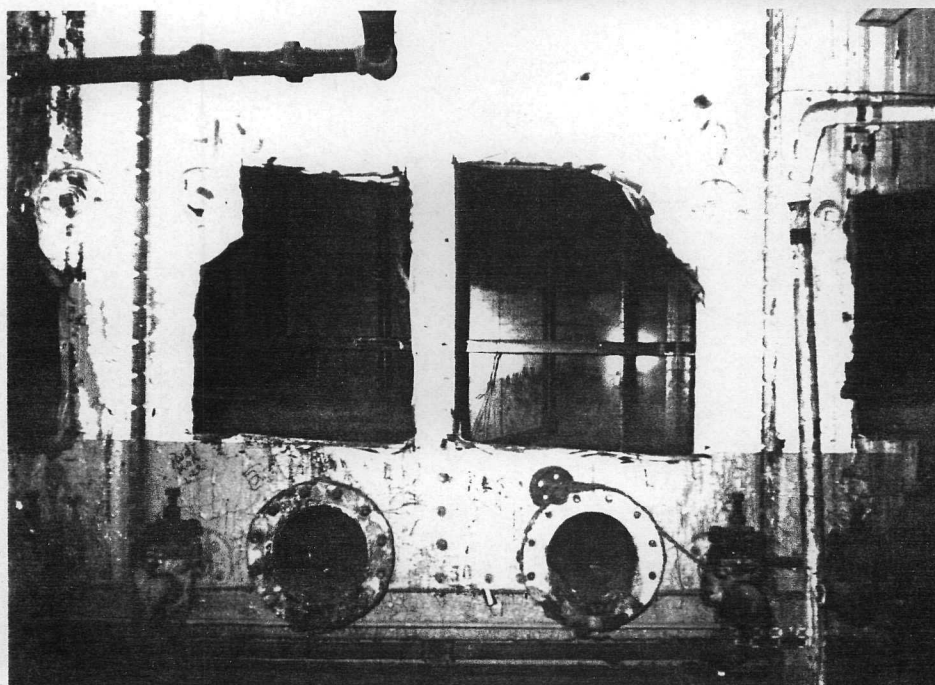
Photograph No. 46
Orientation: North
Description: This picture shows two of the tanks in Building 6 that have been cut open. Many other tanks in this building have also been cut open and drained.

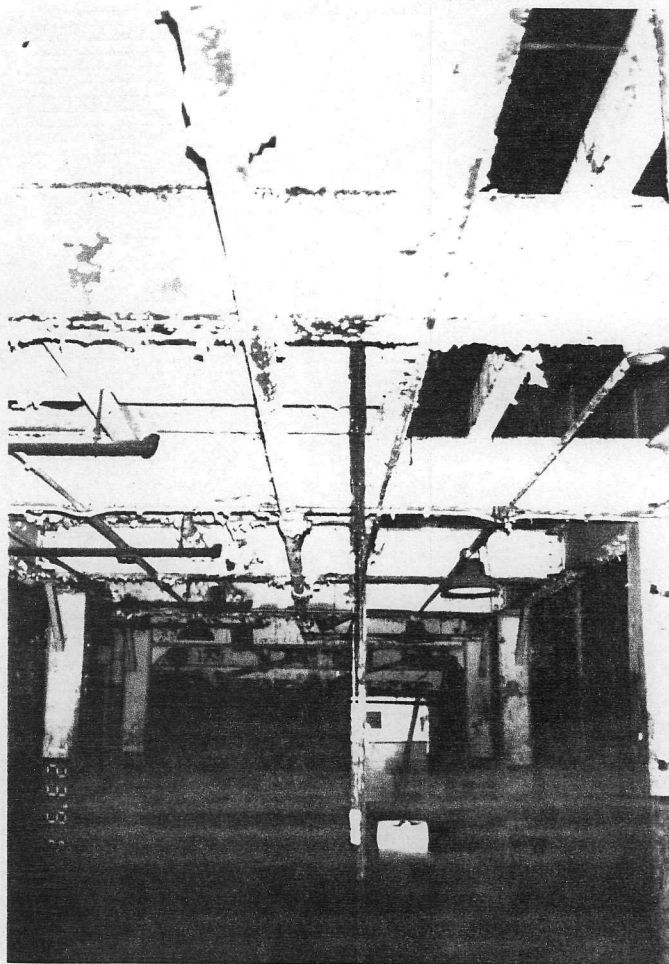
Photograph No. 47
Location: Building 6
Orientation: West
Date: 07/23/91
Description:

This picture shows what is likely to be resin dripping from an unknown source above the overhead walkway. Because large portions of the walkway had been vandalized, PRC did not attempt to locate the source of this leak. Note the peeling paint.

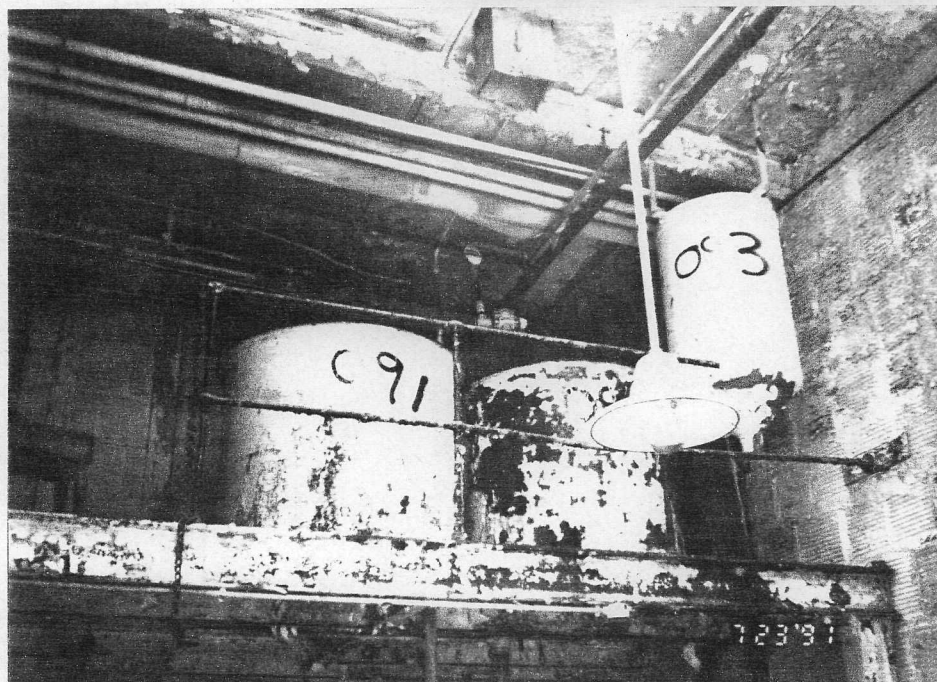
Photograph No. 48
Orientation: South

Description: This picture shows Tanks 91, 92, and 93. They are located on a deck built into Building 6-A.

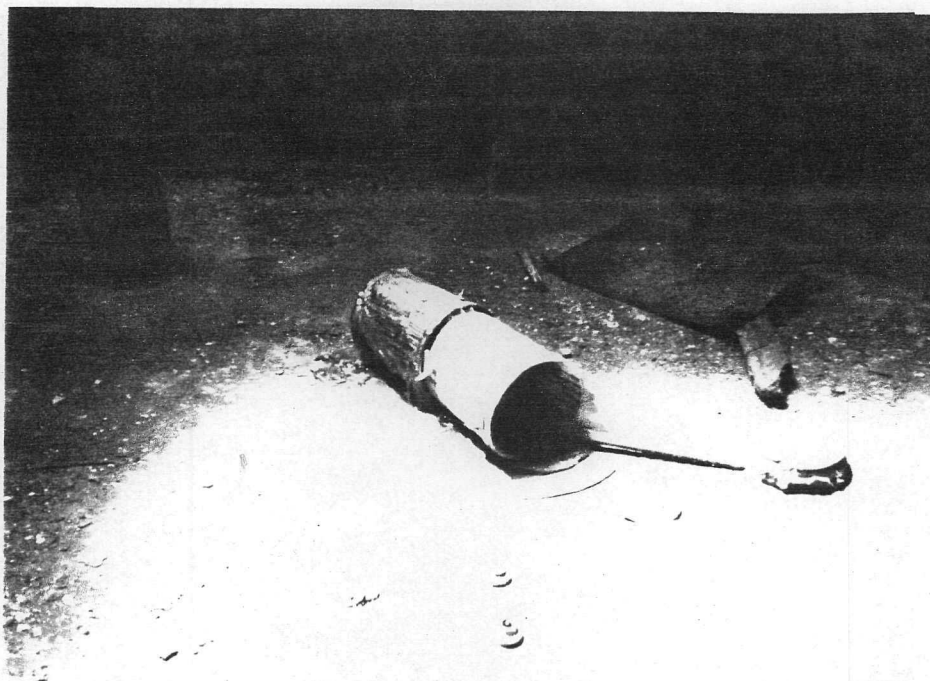
Photograph No. 49

Description: This picture shows the floor of Building 6-A. Two pails lying on their sides were leaking their contents to the floor during the VSI.

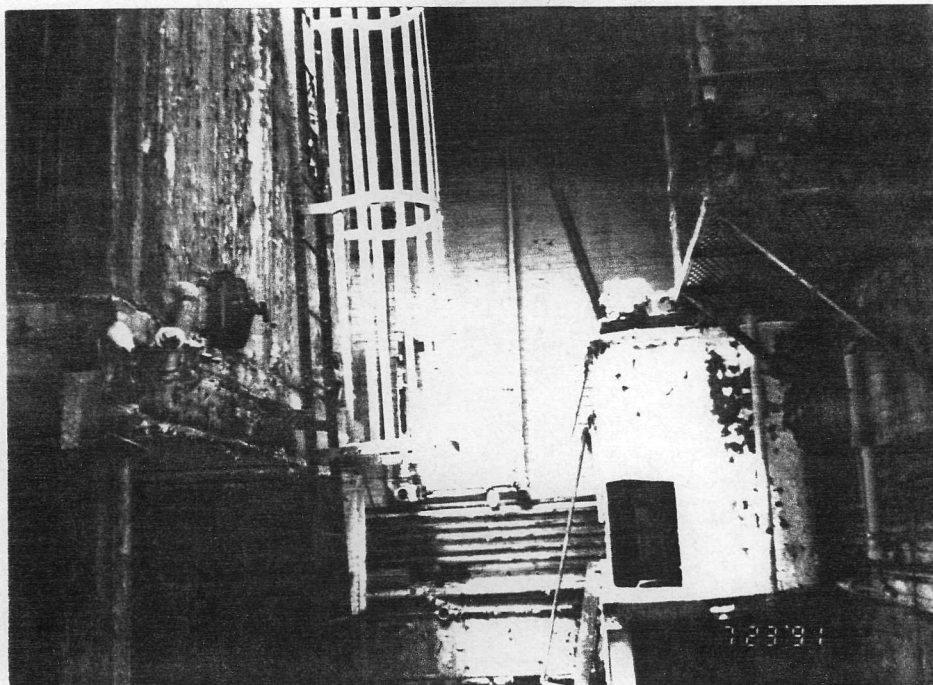
Photograph No. 51

Description: This picture shows the two tanks located in Building 5-B. Note that the smaller of the two tanks (right side of the picture) has been cut open and drained. Also note the peeling paint.

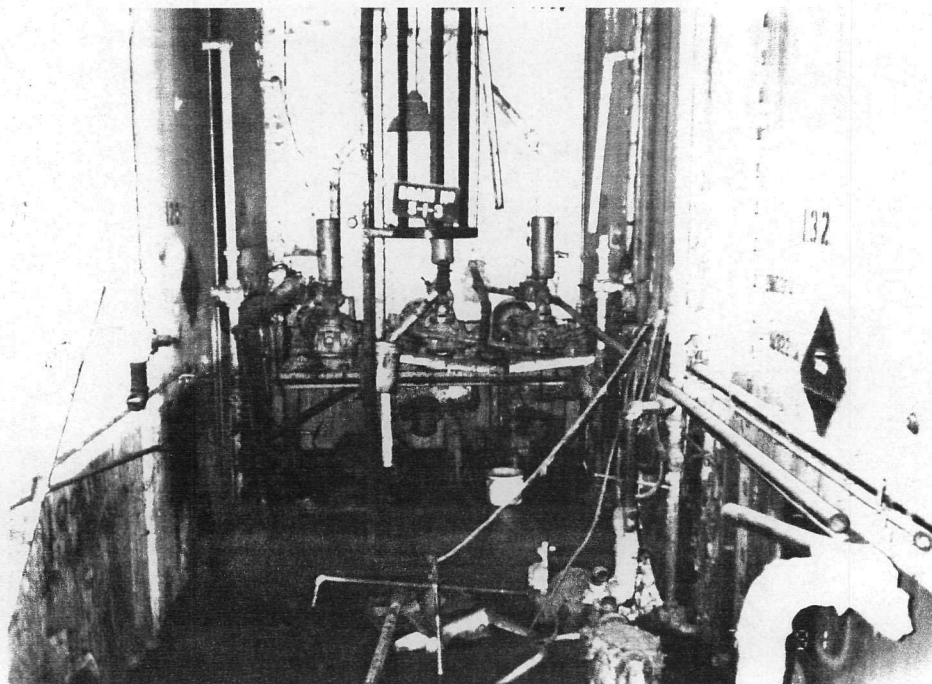
Photograph No. 52

Description: This picture shows the interior of Building 5-C. PRC could not enter this room because the floor was covered with 2 to 3 feet of dark-colored liquid. Note that some of the pipelines in the background have been cut and drained.

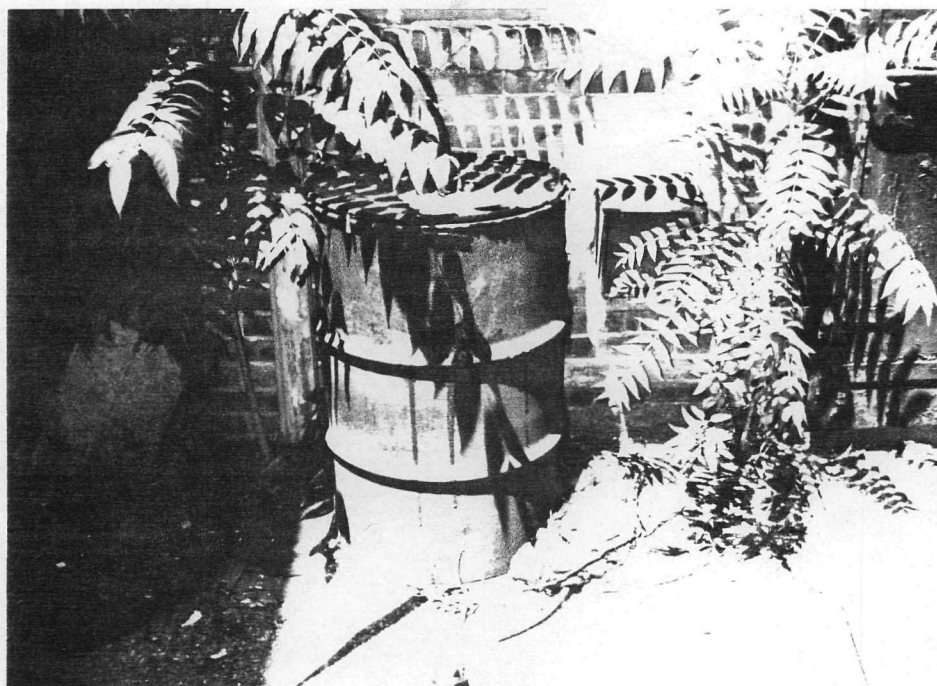
Photograph No. 53

Building 5-D is a small, one-story building located west of Building 5-C (see photographs 53 and 54). PRC observed one drum inside and one drum outside this building. Using a PID, PRC determined that both drums contain volatile constituents. Both drums were slightly rusted, and neither drum was sealed. Debris was observed inside and outside this building. PRC determined that this building contains a floor space of approximately 200 square feet (see Table 1).

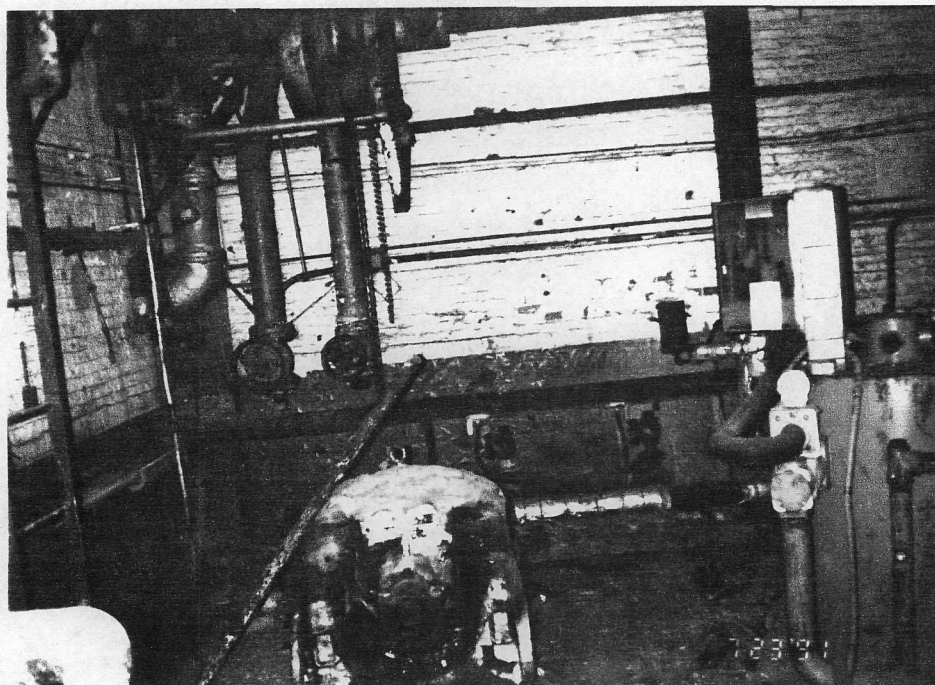
Photograph No. 55

The complex of Buildings 9, 9-A, 9-B, and 9-C appear to have been used as the source of power for the facility when it was operational (see photographs 55, 56, 57, and 58) (Armstrong Paint, date unknown). Building 9-A and 9-C are two-story buildings, and the other two buildings are one-story structures. The first floors of these buildings all contain electrical equipment in various stages of disrepair. PRC observed at least two boilers, one engine, and several control panels that had been partially torn from the wall. The engine was resting in a brown liquid with oily sheens on its surface. PRC observed pools of black, oily materials near the west end and in the center of Building 9-C and oily stains on the walls and floors in all the buildings. PRC observed one empty drum in Building 9-A. The floor of every building was covered with debris and rubble piled to 1 foot high in places. The rubble consisted of concrete, metal, and wood scraps, white powders, dust, and chipped paint from the walls and ceiling. PRC also observed deteriorated piping insulation in these buildings. PRC observed two sealed, 55-gallon drums in Building 9. The ceilings in Buildings 9 and 9-C were quite high, approximately 30 to 50 feet above the floor level in places. Information obtained by PRC after the VSI indicate that three underground storage tanks containing fuel oil for the boilers and engines are located in Building 9-C. Two of these tanks have a capacity of 25,000 gallons; the third has a capacity of 10,000 gallons (IT, 1990b). PRC did not locate the accessways or fill pipes to these tanks during the VSI. PRC determined that these four buildings have a combined floor space of about 5,400 square feet on the first floor (see Table 1).

Description: This picture shows part of the boiler room. Note the dark stains along the wall in the background. They may be caused by boiler oil containing PCBs.
